Subject: Request for Emergency Response Assistance

Former Ramada Hotel 4300 West Pierson Road

Flint (Mt. Morris Township), Genesee County, Michigan

Asbestos and Hazardous Materials Survey, Dated September 19, 2011, prepared by AKT Peerless Environmental & Energy Services.

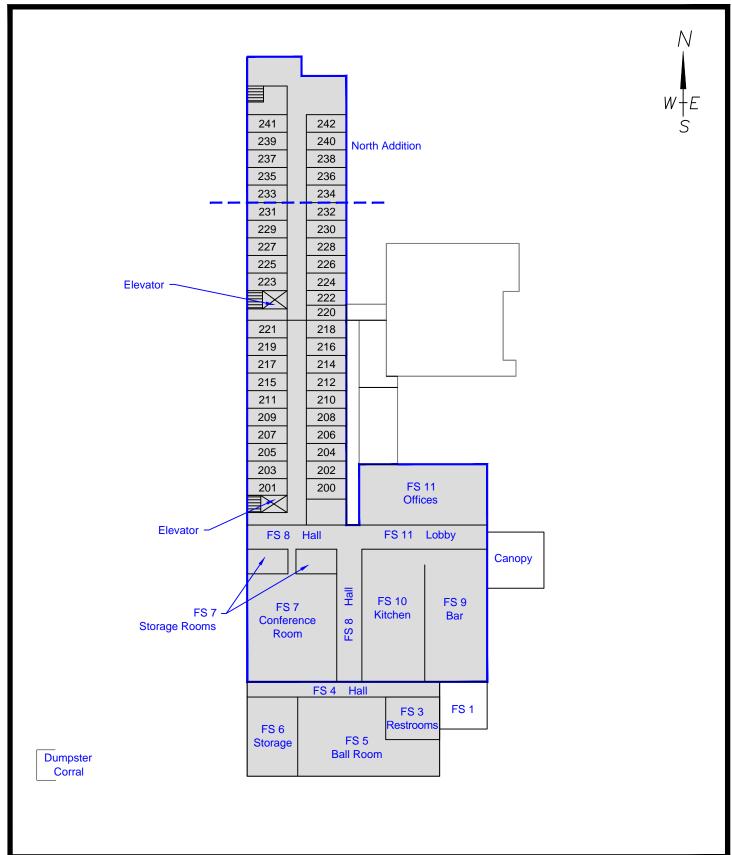
DRAWN BY:	OGO	
DATE:	08-04-11	
0 30 SCALE: 1'		
FIGURE 3

FUNCTIONAL SPACE MAP-2ND FLOOR & BAR/CONFERENCE AREA

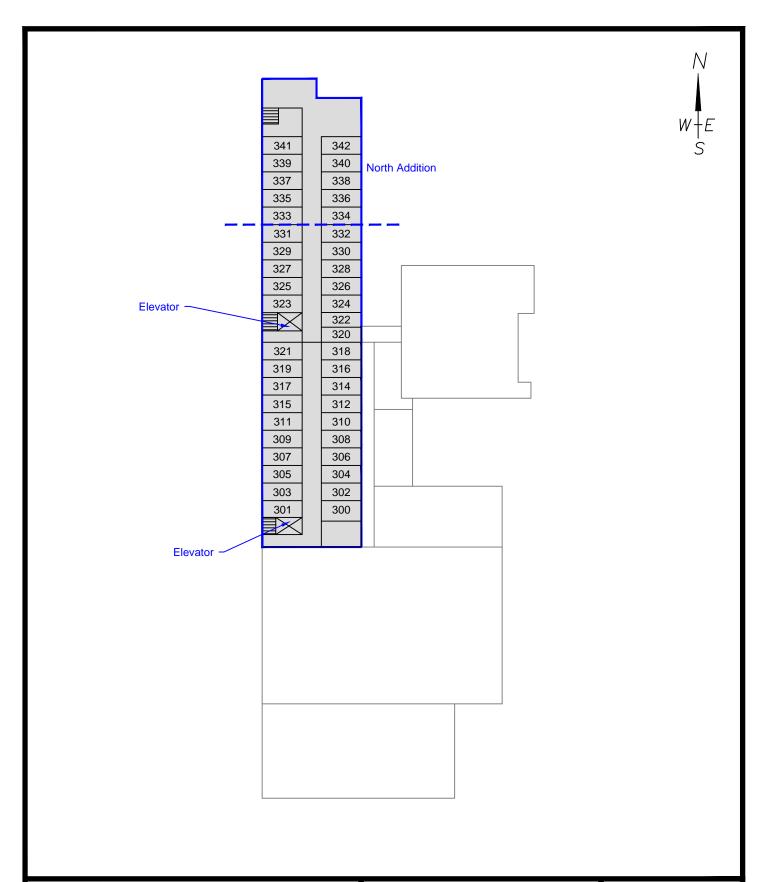
DRAWN BY:	OGO
DATE:	08-04-11
0 30 SCALE: 1'	
FIGURE 4

FUNCTIONAL SPACE MAP-3RD FLOOR

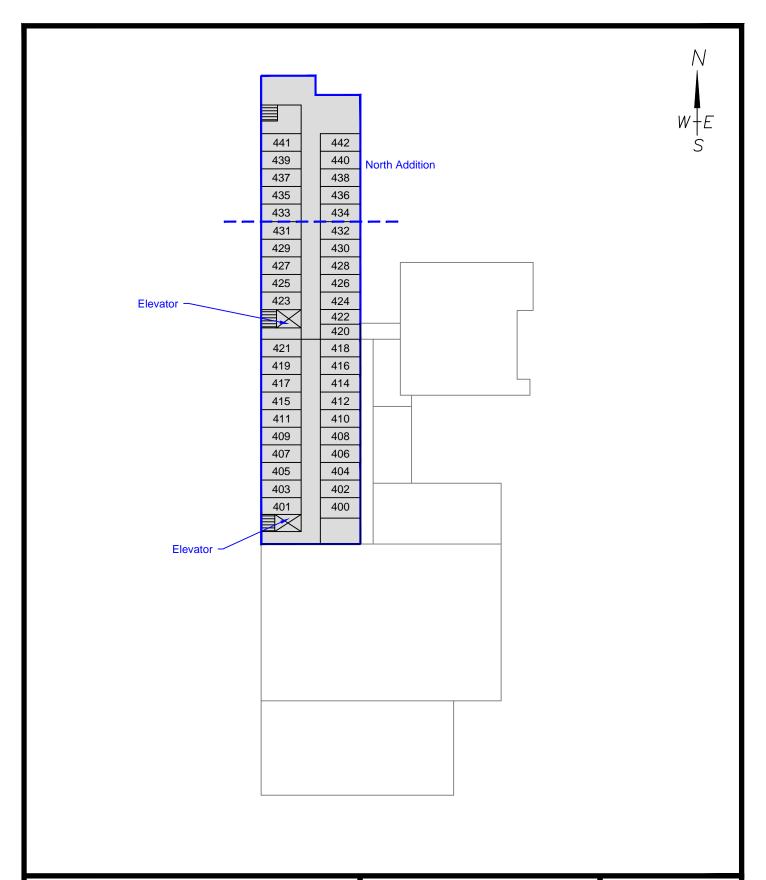
DRAWN BY:	OGO
DATE:	08-04-11
0 30 SCALE: 1'	
FIGURE 5

FUNCTIONAL SPACE MAP-4TH FLOOR

SUBJECT PROPERTY LOCA		
	FUNCTIONAL SPACE MAP		
	FUNCTIONAL SPACE MAP		FERENCE AREA
	FUNCTIONAL SPACE MAP		
FIGURE 5	FUNCTIONAL SPACE MAP	– 4 <sup>TH</sup> FLOOR	
FIGURE 6	FUNCTIONAL SPACE MAP	-5 <sup>TH</sup> FLOOR

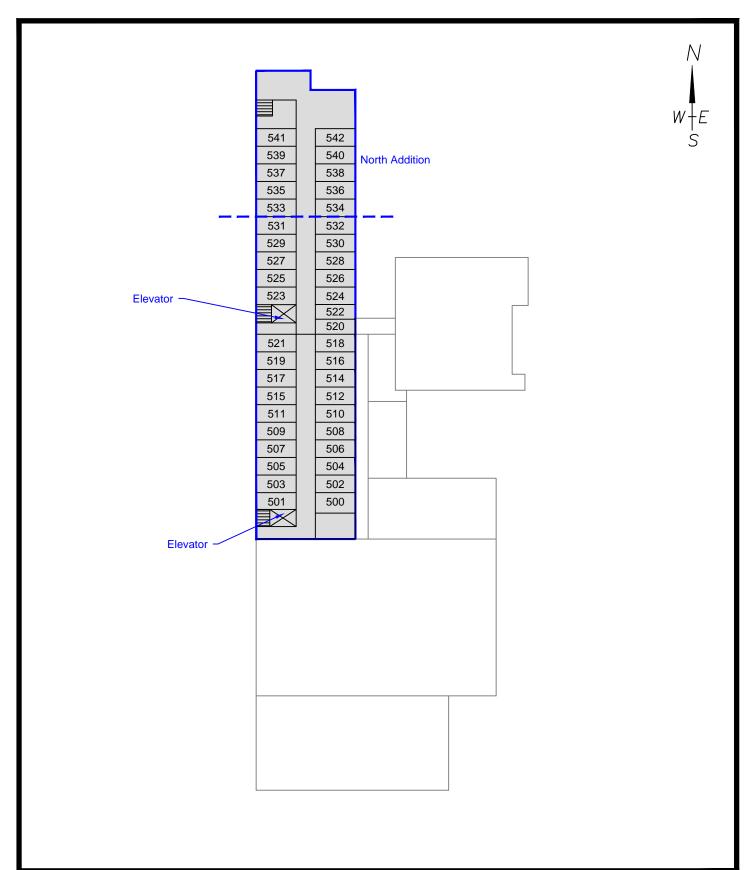
FUNCTIONAL SPACE MAP-5TH FLOOR
